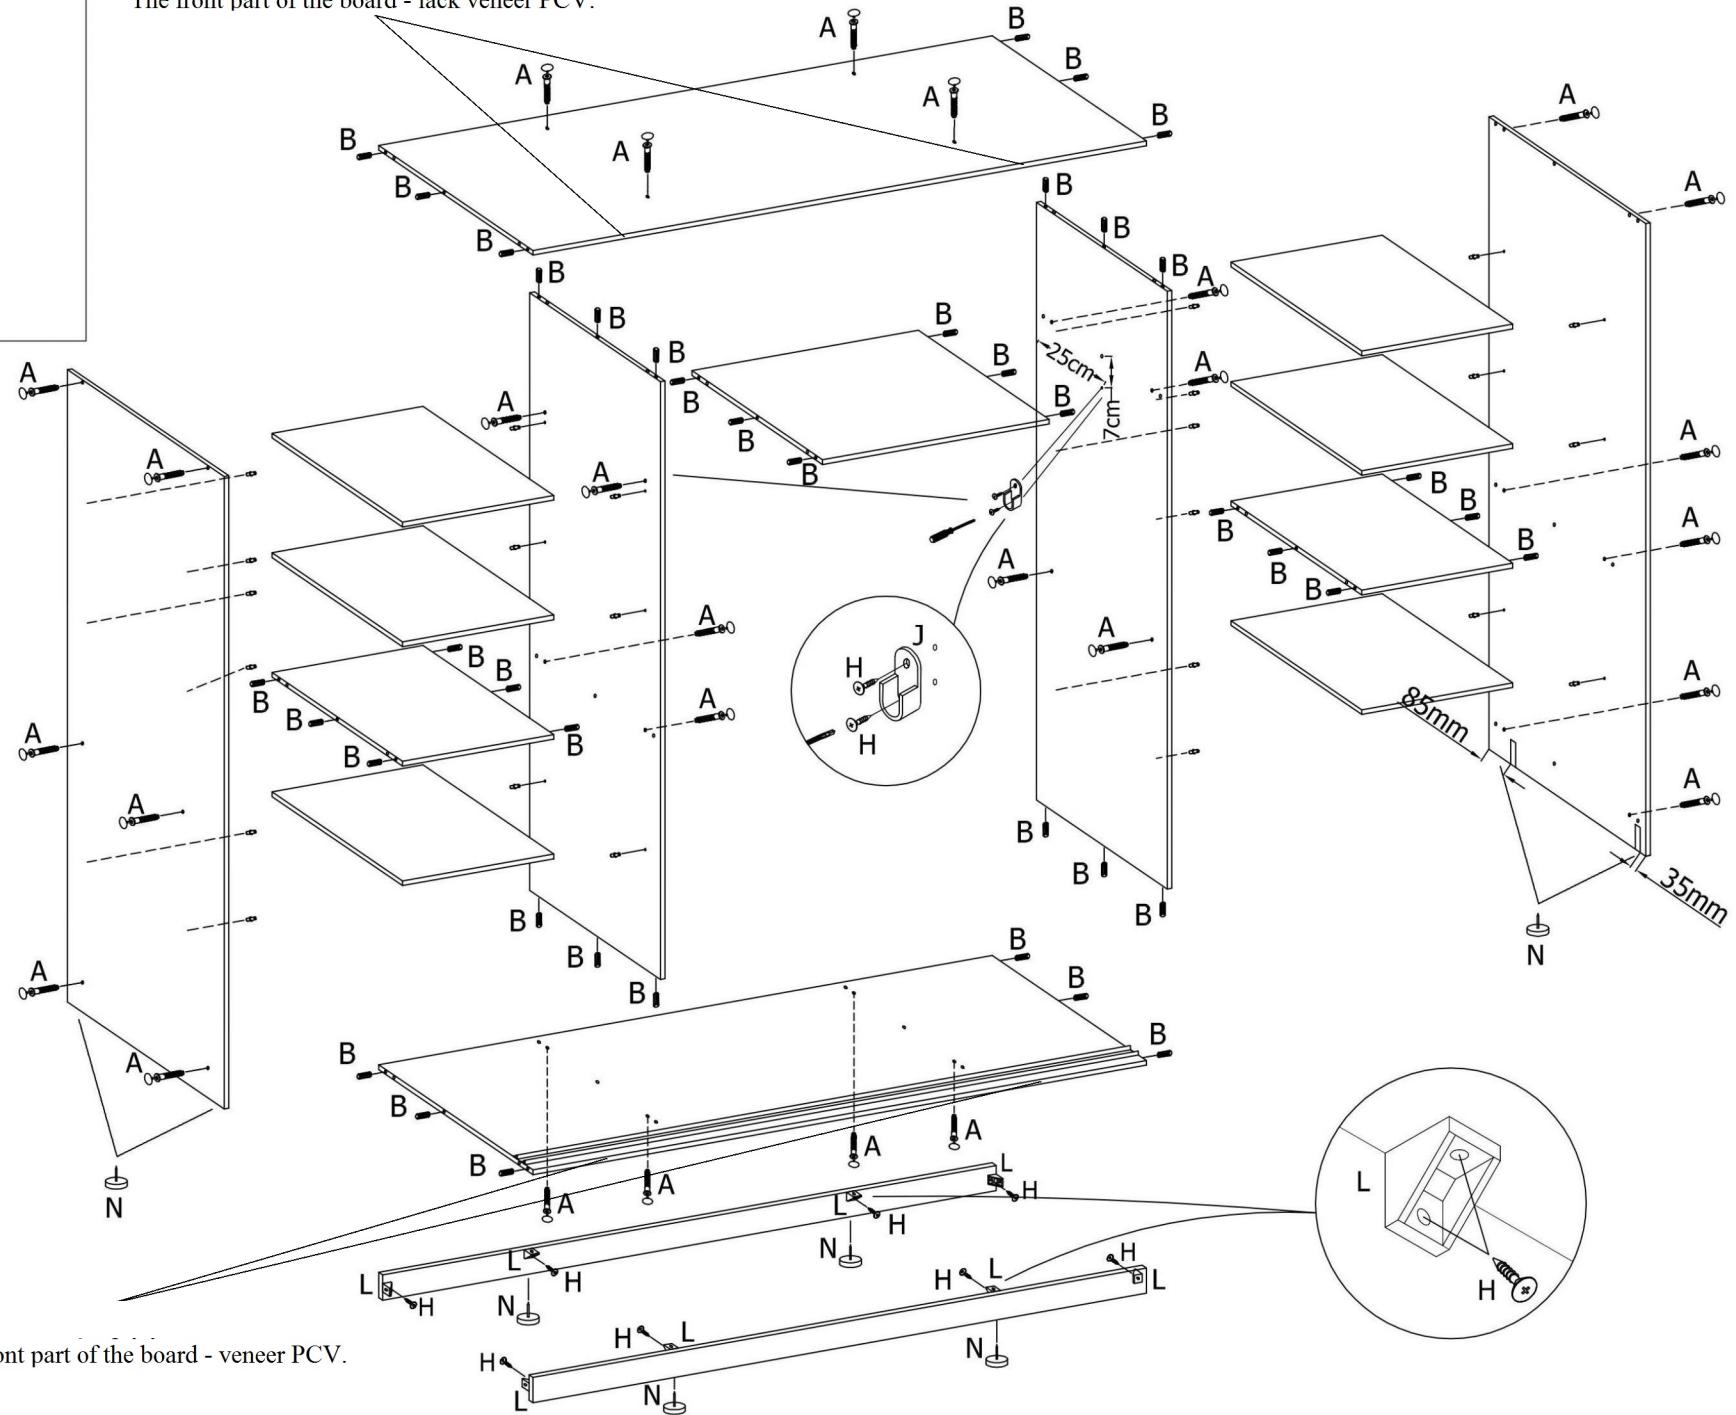
The front part of the board - lack veneer PCV.
